Fact Sheet:

Janus International Tests Zinc Enriched Extreme Environment Protection Coatings

Performance Testing

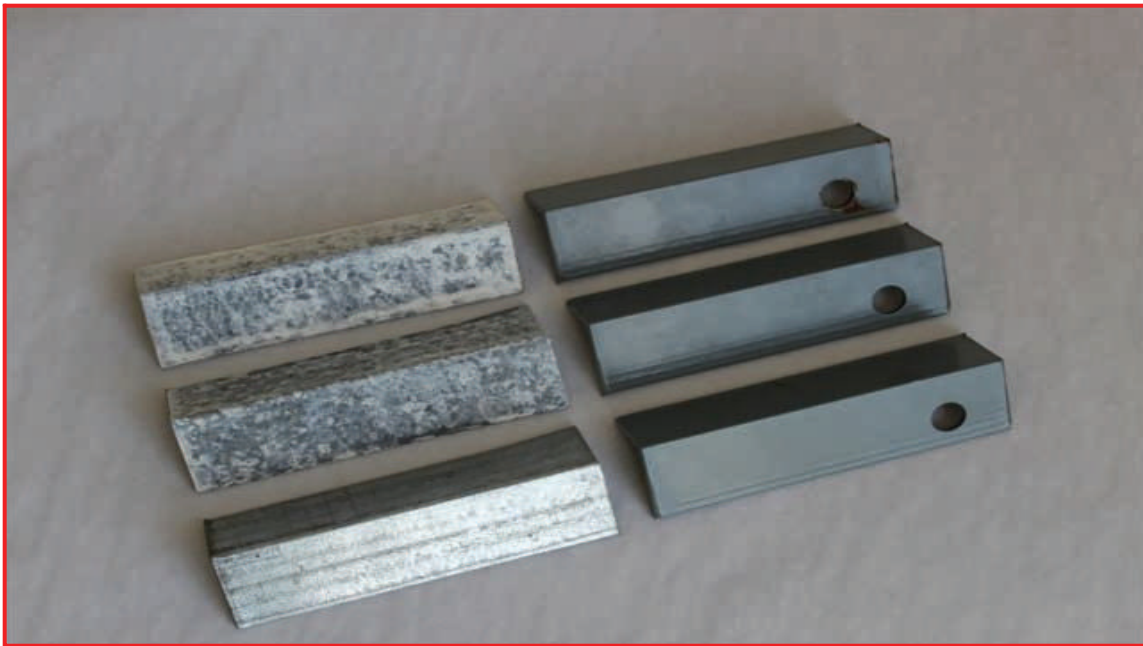
Actual un-retouched test samples

Shown at left are three 1.5" x 1.5" samples of structural guide material galvanized per ASTM A123. At right are three samples tested with the new Janus Extreme Environment Protection coating (EEP), a proprietary, baked-on, super tough factory process coating with high zinc content that defeats corrosion and decay more decisively than traditional galvanized steel.

Methodology: Concurrent salt spray exposure was as follows: Bottom pair of angles was the control with zero exposure. The middle pair of angles demonstrates the result of 174 continuous hours of salt spray. The upper pair of angles is the result of 360 continuous hours of salt spray – both exposures per ASTM B-117 using evaluation method D610.

Conclusion from the testing laboratory after 360 hours: Substantial oxidation and staining occurred on the galvanized product after 360 hours in salt spray cabinet. The film integrity and general physical appearance of the Janus EEP coating remained intact with only slight corrosion around thin film areas. It is our conclusion that the Janus EEP coated product conclusively outperforms the standard ASTM A123 galvanized product in accelerated salt spray testing.

Substantial oxidation and staining occurred on the galvanized product after 360 hours in salt spray cabinet. The film integrity and general physical appearance of the Janus EEP coating remained intact with only slight corrosion around thin film areas. It is our conclusion that the Janus EEP coated product outperforms the standard ASTM A123 galvanized product in accelerated salt spray testing.
